# Results and experiences from the plastic litter monitoring in the BLASTIC pilot areas

| <b>Project</b> | BLASTIC - Plastic waste pathways into the Baltic Sea |
| <b>Work package</b> | WP3 Results from plastic litter monitoring in the pilot areas |

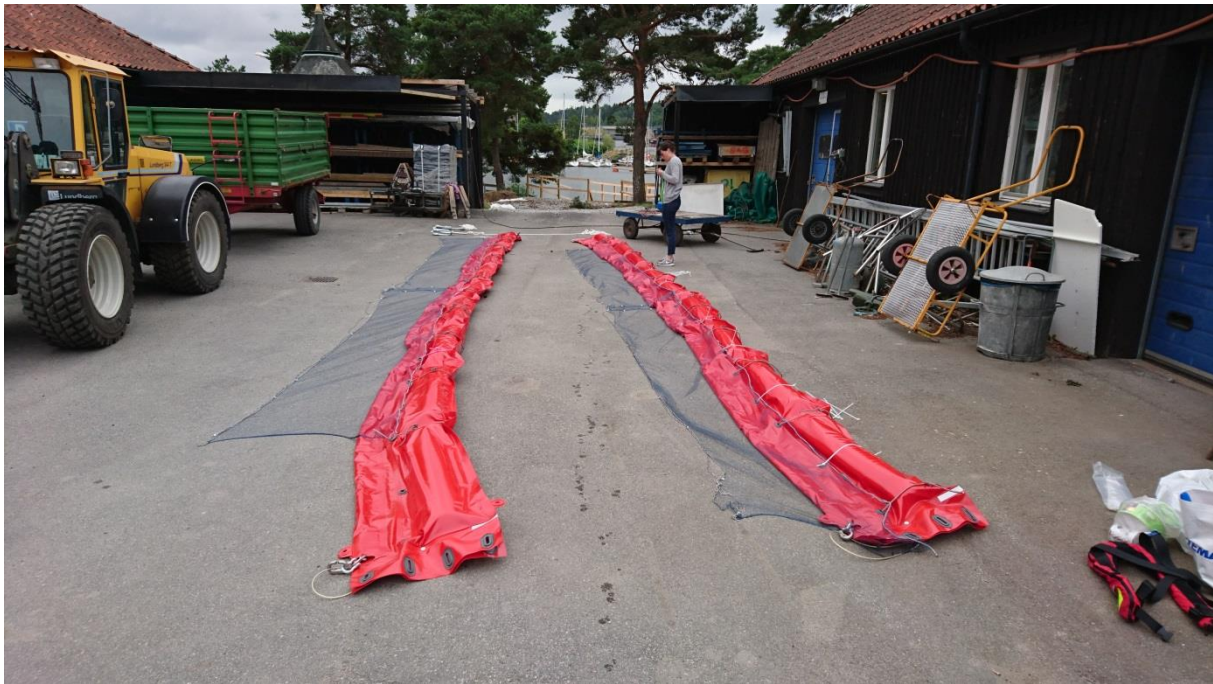
The floating litter booms used within BLASTIC were modified cylindrical containment booms (Sjuntorp C500). The general area of use for these booms is to contain oil and/or chemical spills or protect areas against floating contamination agents. As the C500 was designed for rapid and easy deployment and several booms could be connected to get a desired length they were chosen for the project. The booms were modified with additional loops so that net curtains easily can be connected to them.

**Figure 1. Litter booms (C500) equipped with net curtains.**

The first version with a net curtain hanging down at the bottom of the litter boom created big gaps between the net and the litter boom, as the loops where the net was attached was at the bottom of the litter boom. As plastic and other debris may "leak" through these gaps during the monitoring and retrieval of the boom another solution to attach the net curtain was considered.

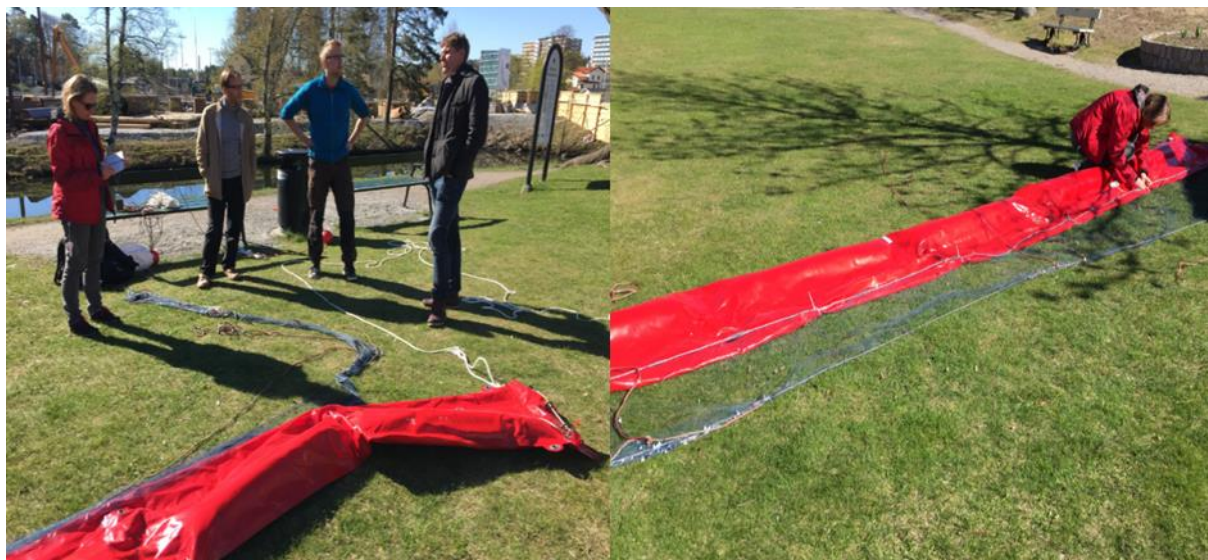
- It is important to bring landing nets to capture the litter when retrieving up the booms.
- Chains at the end of the net curtains are needed to keep the nets in place.
- The mesh size of the net curtains should not exceed 15 mm. The mesh size used during the test was 8.5 mm.

**Figure 2. Test of the equipment setup in Södertälje.**

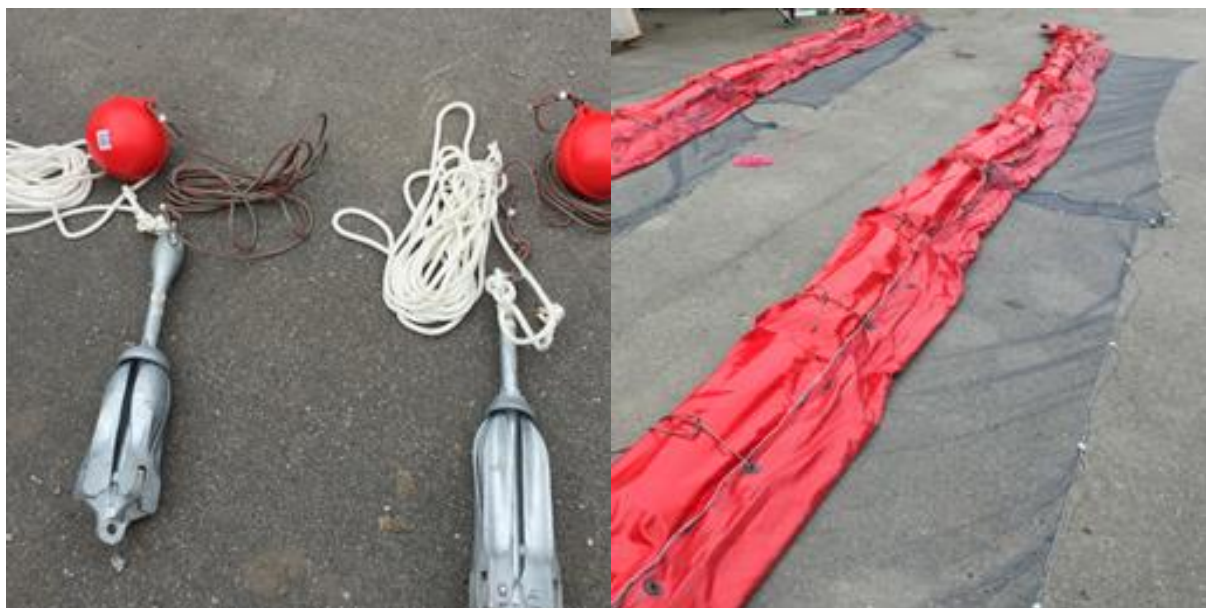
**Figure 4. Grapnel anchors with marking buoys.**

The grapnels used for the mooring of the litter booms were too heavy in this pre-trial. Grapnels with the weight of 8 and 10 kg were tested. The size of the grapnels will be depending of factors that are site specific (bottom substrate and speed of the current) and the size of the litter boom. At this specific site with a soft bottom grapnels weighing 6 kg would have sufficed for the 10 meter boom. The rope length between grapnel and boom is recommended to be at least twice the depth of the water.

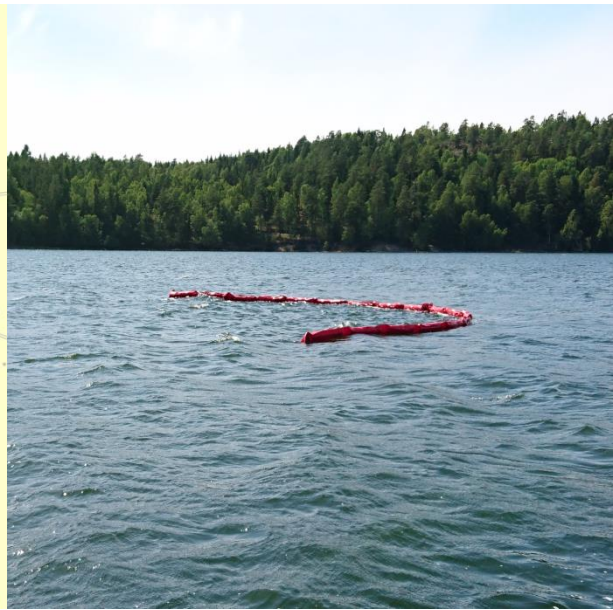
Boom 1 was placed in Hallsfjärden, which is the most northern part of a bay of the Baltic Sea that is located in the municipality of Södertälje (Figures 6 and 7). The monitoring location was a relatively narrow part (550m wide) of Hallsfjärden approximately 8.5km downstream from the floodgate in Södertälje channel. Boom 1 one was placed close to a shallow next to a shipping lane. Due to heavy shipping in Hallsfjärden it was not possible to place the litter boom in the middles of the bay. The depth at the site was about 6 m. Boom 1 covered about 3.5% of the total width of the bay at that location. Boom 1 was moored approximately 140-160 m from shore on soft bottom sediment.

**Figure 7. Boom 1 deployed in Hallsfjärden**

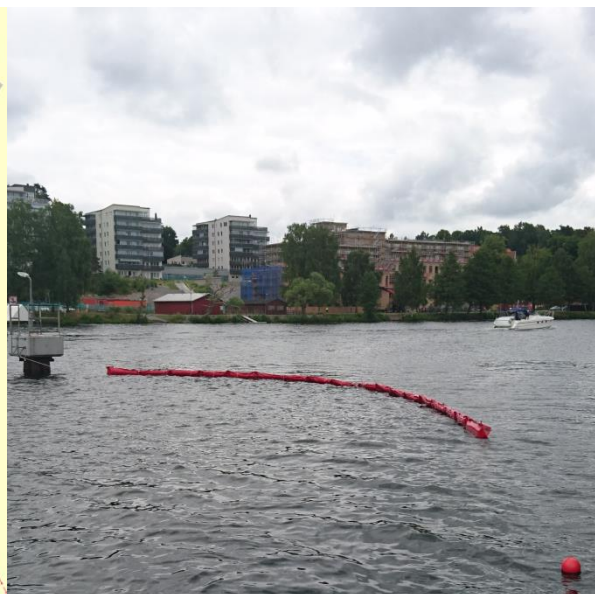
**Figure 9. Boom 2 deployed at Södertälje channel inlet.**

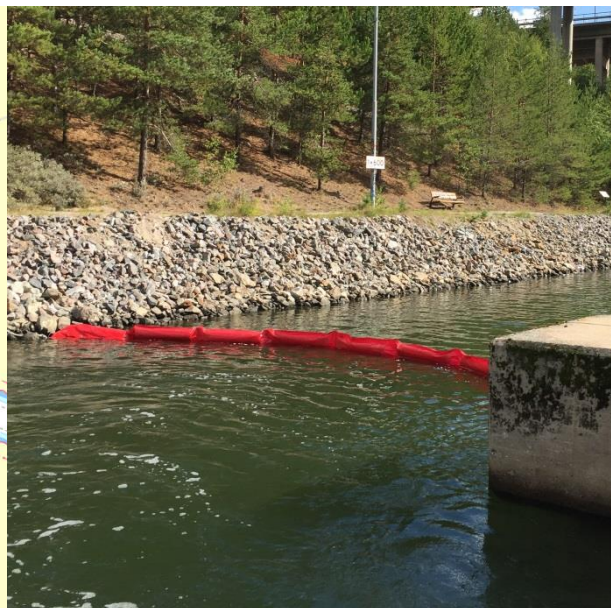
Boom 3 was placed in Södertälje channel near the channel bridge about 0.9km downstream from the floodgate (Figure 10 and 11). The water downstream from the floodgate is considered to be the Baltic Sea. The litter boom was placed between the shore and a concrete foundation in the channel. Due to heavy shipping it was not possible to place the litter boom in the middle of the channel. The depth at the site ranged between 2-3m. Boom 3 covered a total of about 15% of the width of the channel (~67m) at that location. Boom 3 was moored at a fixed point at shore in one end and the other end was moored to a concrete foundation about 10m from shore.

**Figure 11. Boom 3 deployed at Södertälje channel bridge.**

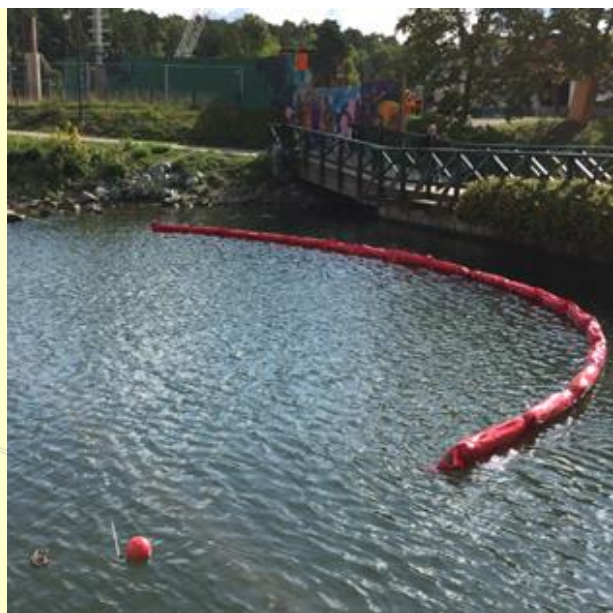
Boom 4 was placed in a small outlet in central Södertälje City called Maren (Figure 12 and 13). This outlet runs parallel to the floodgate in the city center. There is no shipping or boat traffic in Maren so the litter boom could be placed in the middle. The depth at the site ranged between 2-3m. Boom 4 covered a total of about 60% of the width of Maren (~33m) at that location. Boom 4 was moored using anchor (on soft bottom sediment) in one end and the other end was moored to a fixed concrete foundation about 3m from shore.

**Figure 13. Boom 4 deployed in Maren.**

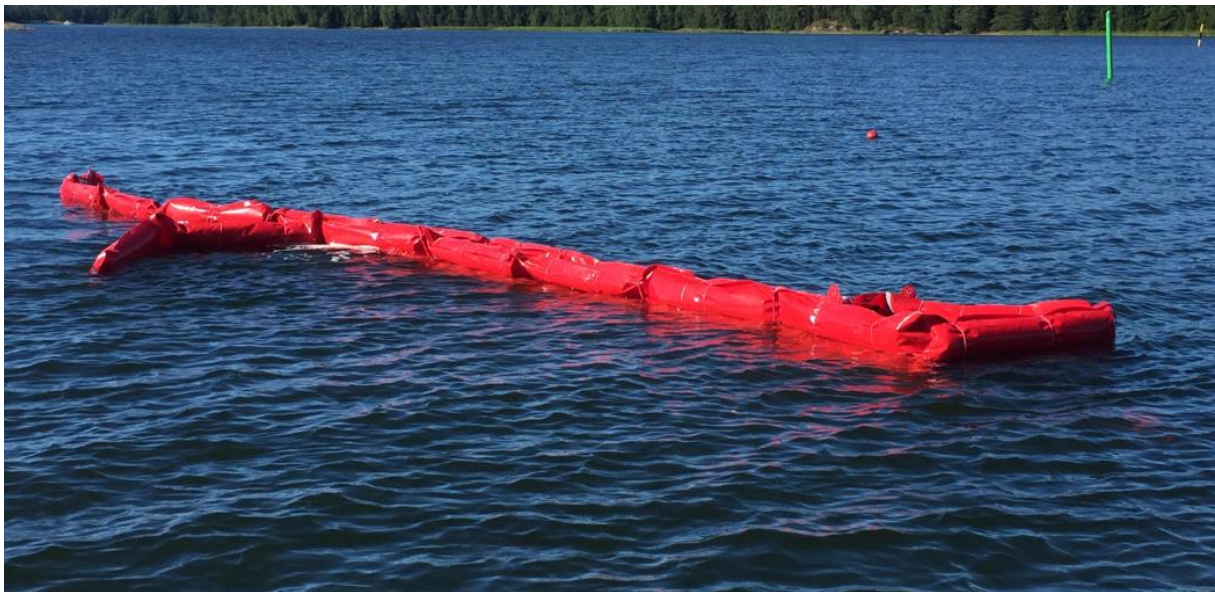
**Figure 16. One mooring point of Boom 1 came out of position resulting in a deformation of the litter boom. It was not able to capture any litter.**

All monitoring sessions encountered problems that affected the results in some way. The moorings of two litter booms (Boom 1 and 3) were compromised, which resulted in a drastic change in shape of the booms so that the booms could no longer capture any litter (see 3.5.1 and 3.5.3 for details). The moorings of Boom 2, 4 and 5 were not compromised. Litter was found in two booms (Boom 4 and 5). These booms were placed in Maren which lies in the city center of Södertälje. No litter was found in Boom 2, which was placed upstream of the city center. Flowmeters were used to measure the flowrate of the water at each site. However it was shown that the flowrate at all sites was too slow for the flowmeters (Oceanics 2030R) to measure. Another type of flowmeter is recommended if the flowrate is  $<10\text{cm/sec}$ .

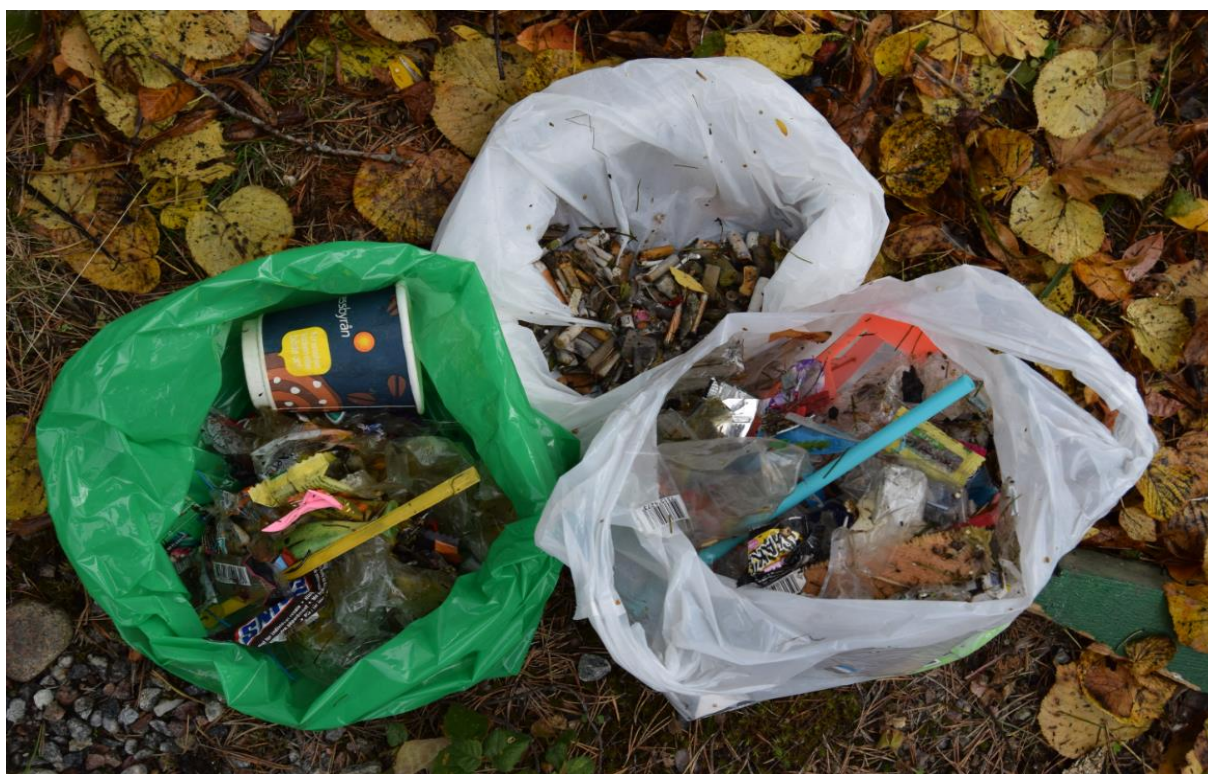
The total number of litter captured was 376. The majority of the litter found consisted of cigarette butts (57%). sweet wrappers (10%). unidentified soft plastics (10%). and unidentified rigid plastic pieces (4%) (Figure 18). “Other non-plastic litter items” mostly consisted of paper and cardboard. In addition to macroplastic debris, a large amount (thousands) of polystyrene beads was sticking on to the boom. These beads were less than 5 mm diameter and are defined as microplastics. These beads were not quantified as microplastics are not included in this study.

**Figure 17. Litter captured in Boom 4.**

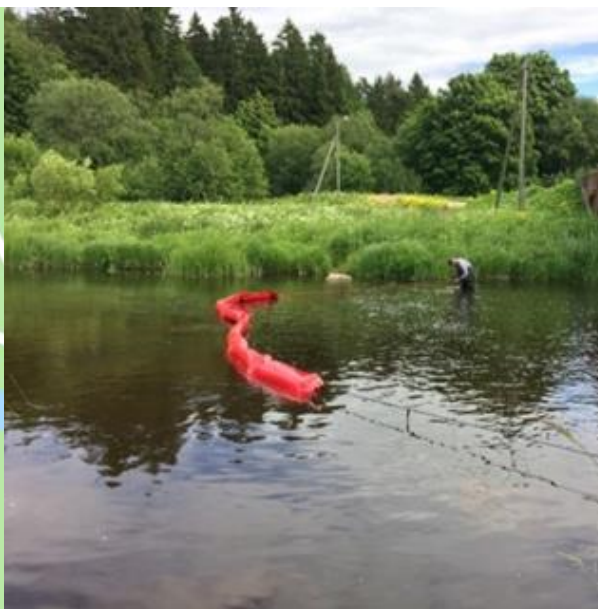
**Figure 21. Installing of the boom set at Pirita Site 1.**

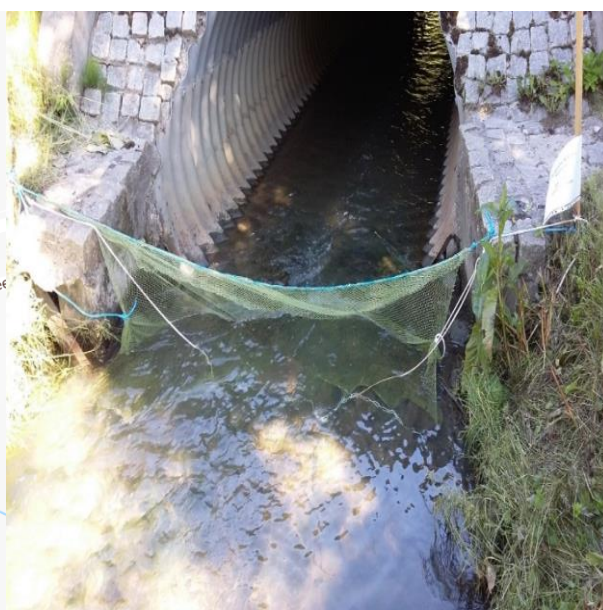
**Figure 25. Set up of the net trap in the Mustjõe river.**

The net trap was used during all three monitoring sessions. The net covered the whole stream (see Figure 25).

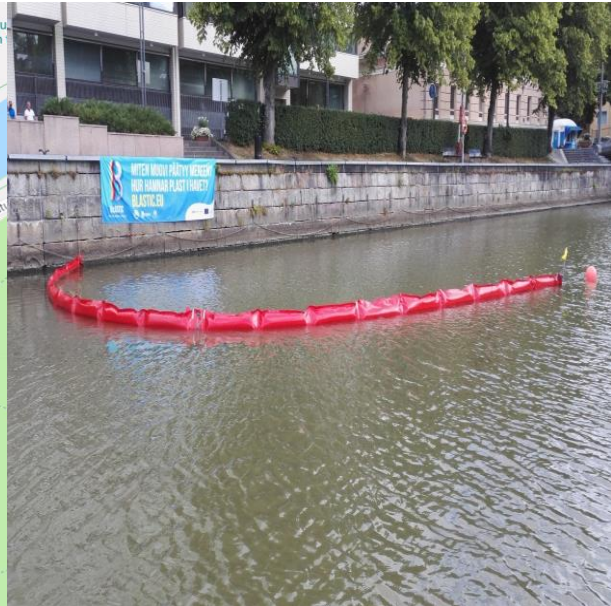
The location of the downstream booms was after bridge called Theater Bridge (Teatterisilta). The downstream booms were placed on the side of the river, anchored to the bottom from one end and attaching it to the river wall from one end (Figure 33). Because of the frequent traffic by city ferries and leisure boats it was not possible to deploy it in the middle of the river. Not only the booms, but especially anchoring ropes could have caused problems. The boom was covering about 12-15 meters of total 60 meters width of the river.

**Figure 33. Downstream boom deployed in Aurajoki. Photo: Pekka Kotilainen.**

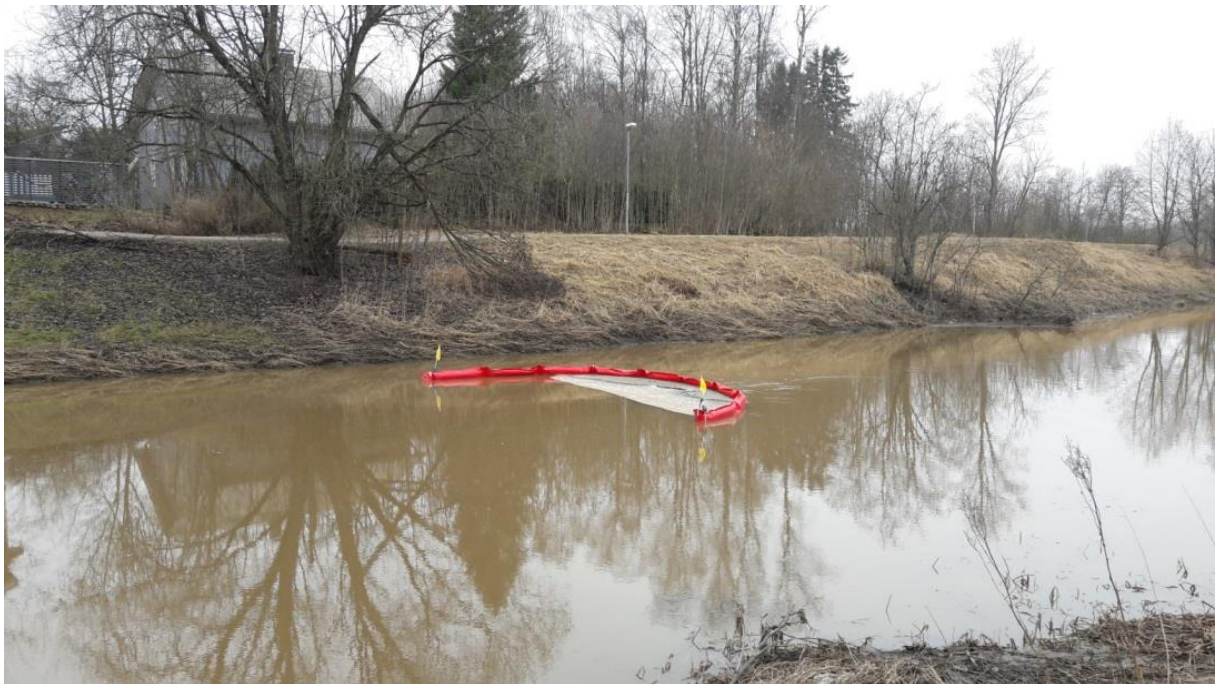
For the monitoring of floating litter, one 10m long boom per study site was deployed (Figure 38). The booms were inspected daily between the 24<sup>th</sup> and 26<sup>th</sup> of April). Litter from the booms was collected, counted and categorized by material and item. The water current profile at each location was measured each morning on the days of litter collection with an Acoustic Doppler Current Profiler (ADCP –device). ADCP measures water currents with sound by using a principle of the Doppler effect.

**Figure 38. The upstream boom at the Kerava branch. Photo: Outi Setälä.**

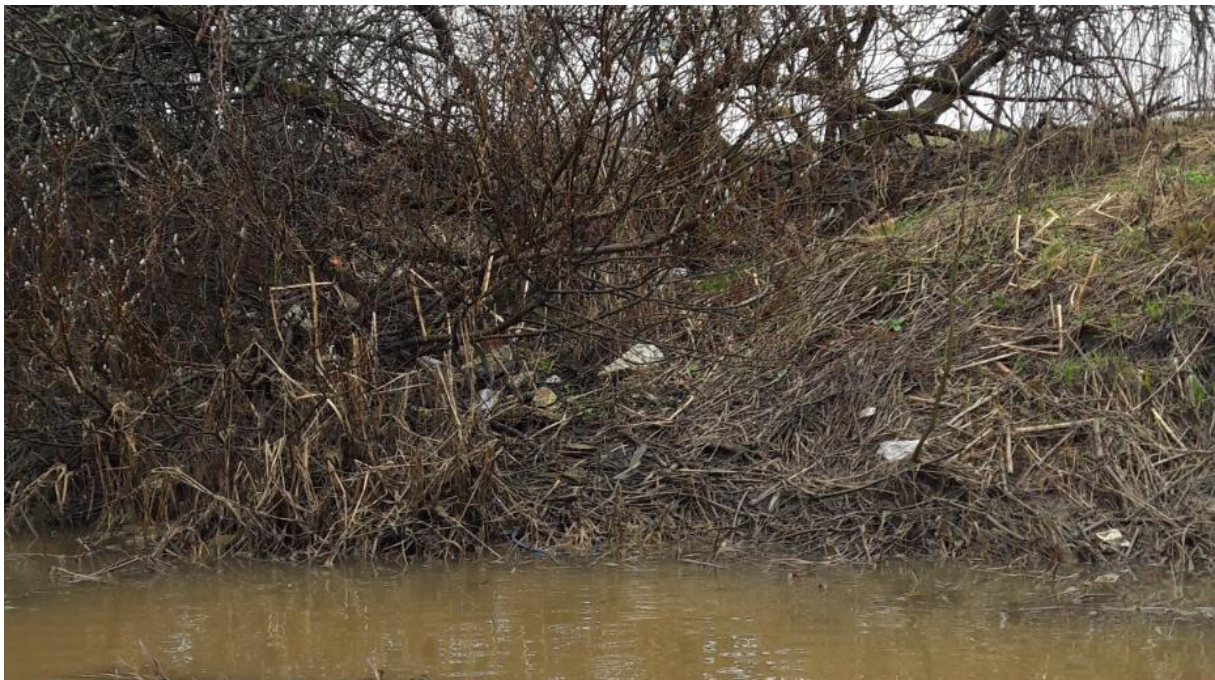
In the year 2018 air temperatures below 0°C prevailed longer than in average years. After this period the temperatures rapidly increased and the thermal spring in the southern parts of Finland started. This resulted in fast melting of snow and elevated riverine water levels. This dynamics was also observed close to the discharge site of the river to the sea, where the water level fluctuated greatly within three weeks: 6.29 m (3<sup>rd</sup> of April), 7.11m (10<sup>th</sup> of April) and 6.49m (26<sup>th</sup> of April). Thus the high water level maximum took place two weeks before the deployment of the booms and had by then already lowered by 62 cm. During the high water period (7<sup>th</sup> to 22<sup>nd</sup> of April) the water discharge was between 45-70m<sup>3</sup>/s at a regular monitoring site in Oulunkylä (500m upstream from the lower boom). Already by observing the amount of litter on the riverbanks it became obvious that the high water period was efficiently transporting various litter items, which were trapped on the river banks when the water level decreased (Figure 41).

**Figure 41. Litter items on the riverbank at the junction of the two rivers.**  
**Photo: Outi Setälä.**

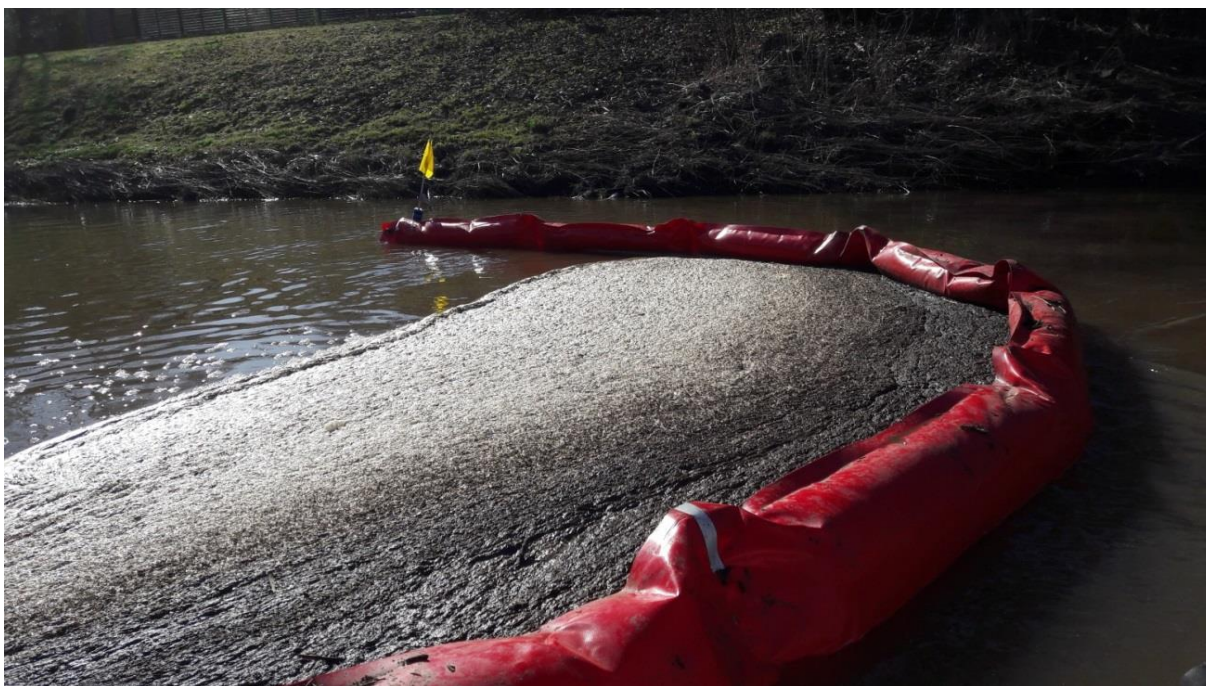
Most of the material which the booms had captured consisted of parts of various plants which were growing on the riverbanks. The suspended material of the river water formed large patches of foam to the boom (Figure 42).

**Figure 42.** Foam formed inside the boom during a 24h period (between two samplings). Photo: Outi Setälä.
